# Case study

## *Monitoring solution for parking garages (New buildings)*

## Project: New Parking garage

**Customer:**  
Public construction authority

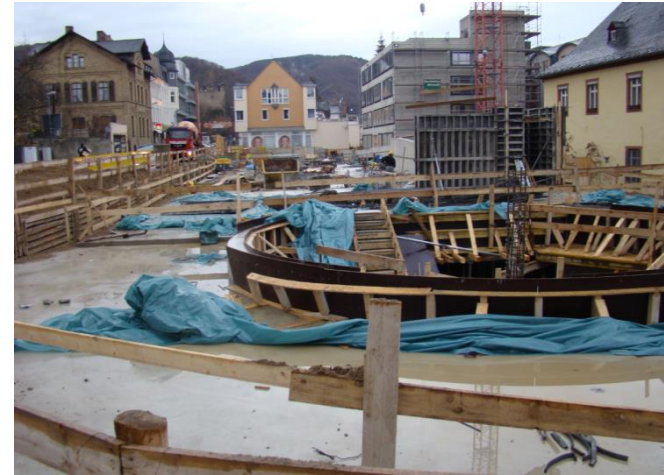
As a result of high repair costs at existing car parks, the city administration had decided to install sensors for humidity and corrosion in the new construction. The background for this is not only the early detection of damage, but also the monitoring of the building to the VOB acceptance and beyond. Because of the special design (covered roof of the parking garage), special emphasis was placed on the humidity monitoring, since the sealing of the roof area is not accessible. Humidity sensors should, among others, be installed at the low mark of the drainage and the ceiling of the parking garage, as well as in the area of drainage joints of the entrance ramps.

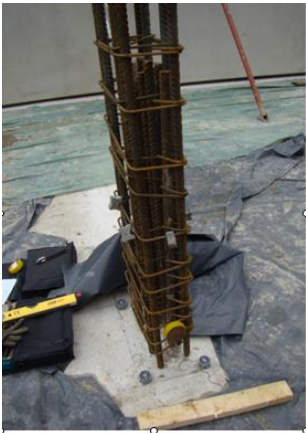
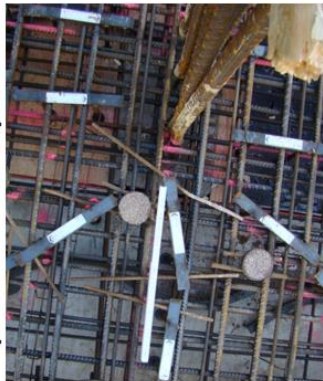
**corroDec**  
2G

Installation of corrosion sensors (standard version) at the pillars of the parking deck and the most frequented parking positions.

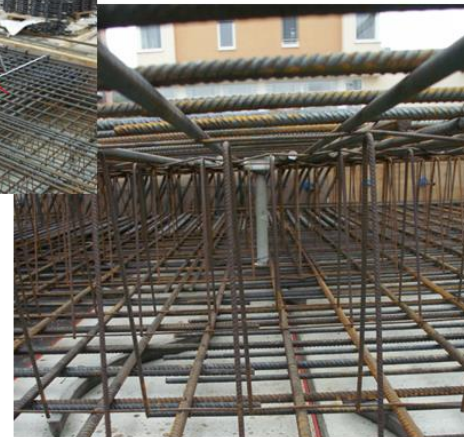
corroDec®  
2G

Installation of humidity sensors (special design) in the area of drainage of the four ceiling panels (40m x 20m x 0.5m) – reading the values from the lower side of the concrete slabs.

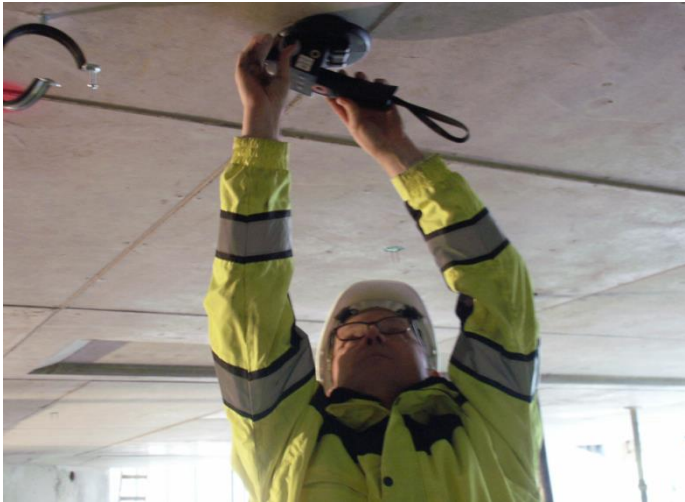
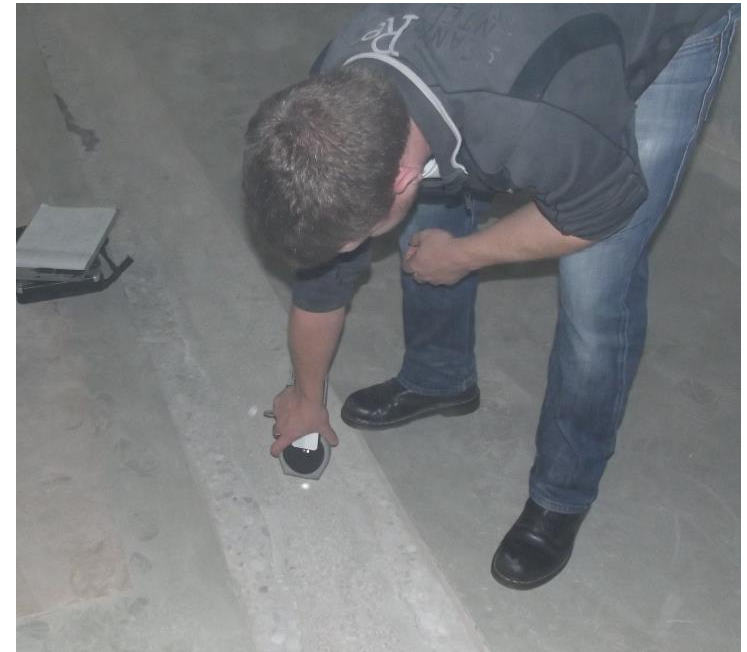
The readout of the data was done manually by a hand held reader. Alternatively, a fully automatic remote reading is available.
